Errata Sheet V1.5 affecting products TC26x_BB

N° 164/17

Device TC26x
Marking/Step (E)ES-BB, BB
Package see Data Sheet

This Errata Sheet describes the deviations from the current user documentation.

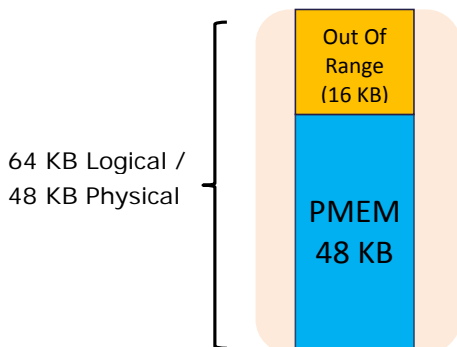
Figure 1 Example for Non-Power of Two PMEM

CPU_TC.125 Unexpected Address Error Alarms caused by Speculative Access to Out-of-range PMEM Areas

In TC26x, the following CPUs and memories are affected:

- CPU1 PMEM

Note: The issue only affects non-power of two PMEM memories of a TC1.6P CPU as described above. Other CPU cores and memory configurations are not affected.

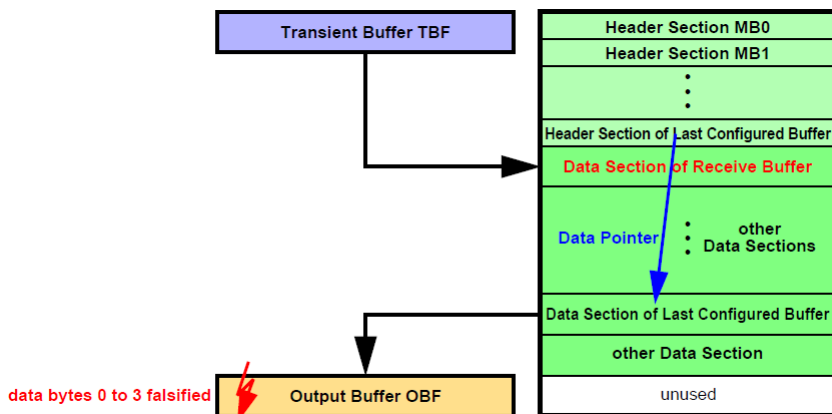
Figure 2 Message buffer transfer from Message RAM to OBF

- a) Message buffer transfer from Message RAM to OBF

When the message buffer has its payload configured to maximum length (**PLC = 127**), the OBF word on address 00h (payload data bytes 0 to 3) is overwritten with unexpected data at the end of the transfer.

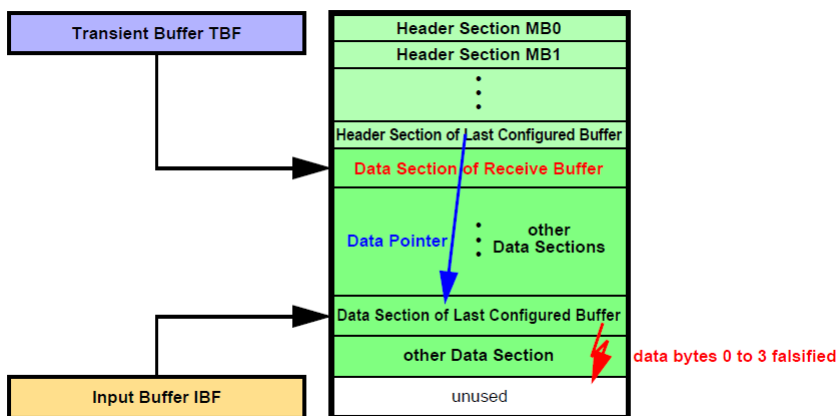
Figure 3 Message buffer transfer from IBF to Message RAM

b) Message buffer transfer from IBF to Message RAM

After the Data Section of the selected message buffer in the Message RAM has been written, one additional write access overwrites the following word in the Message RAM which might be the first word of the next Data Section.

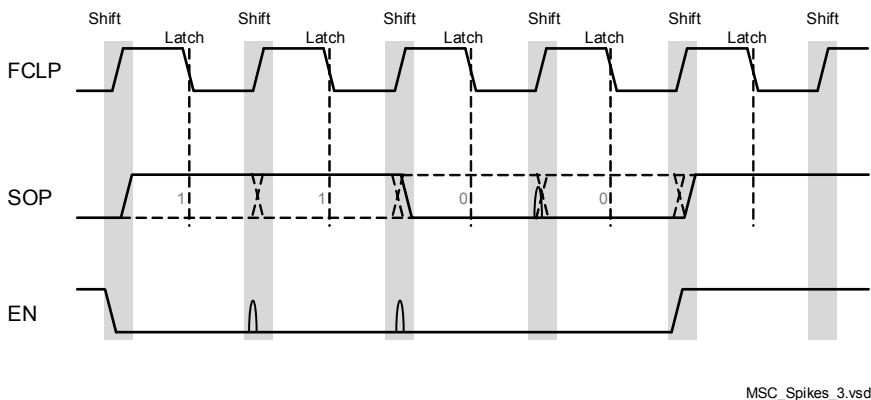
Figure 5 Theoretical Example for MSC Spike Scenario

The ABRA block of the MSC generates spikes in the serial output data (SO) and enable (EN0 to EN3) signals, that under some worst case conditions might become visible at the output of the corresponding pins.

The spikes would appear as shown in **Figure 5**, within the normal signal transition timing intervals, as defined with the data sheet timings t44 (SOPx output delay) and t45 (ENx output delay). The spikes would not cause violation of the timings.

Each MSC module instance (MSC0, MSC1 ...) of each device (TC26x, TC27x, TC29x) shows specific behavior regarding the width of the spikes, depending on the on-chip synthesis of the particular instance.

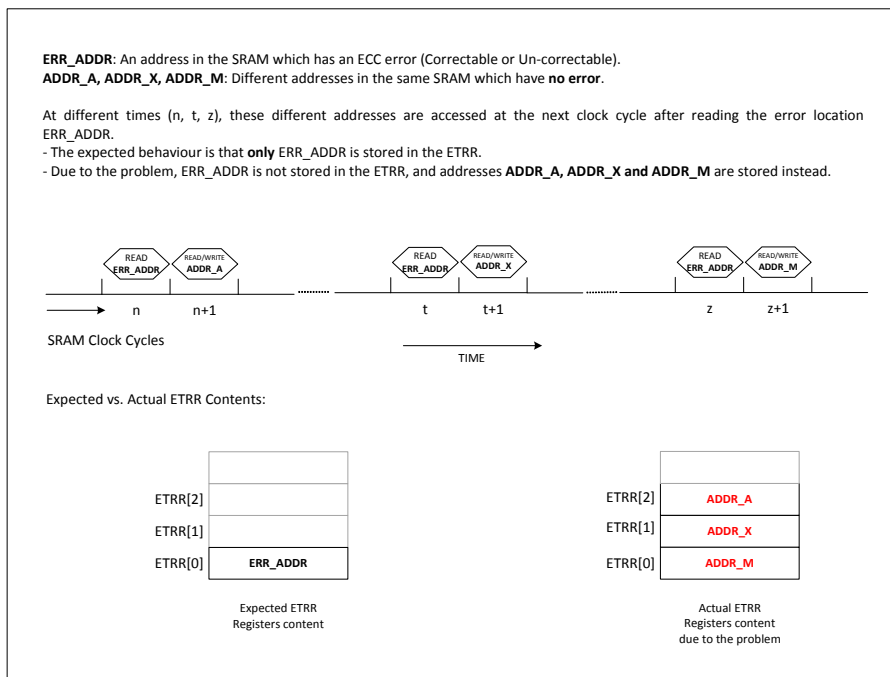
Figure 6 Example sequence showing how registers ETRRx may be filled with “Error Free” addresses

When such a consecutive access sequence (read from ERR_ADDR followed by read/write of different address(es)) happens multiple times, registers ETRRx are filled with addresses that have actually no error – and the SRAM address which actually has an error is not stored indeed. **Figure 6** shows such an example scenario.

The consequence of the scenario explained in **Figure 6** is that a single error in the SRAM – example just one correctable error at a location ERR_ADDR – can result in registers ETRRx getting filled with fault-free address, and thus potentially even triggering an ETRR overflow.

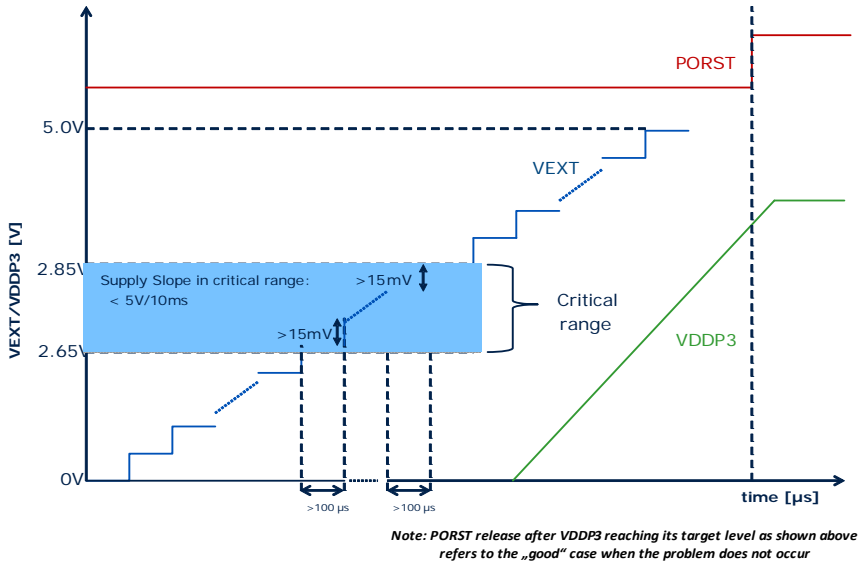
Figure 9 EVR Supply Voltage VEXT Ramp-up - Critical Range

- The fail behavior is observed only if the internal EVR33 regulator is used.
- The fail behavior is not observed together with TLF35584 regulator (owing to fast ramp-up slopes).

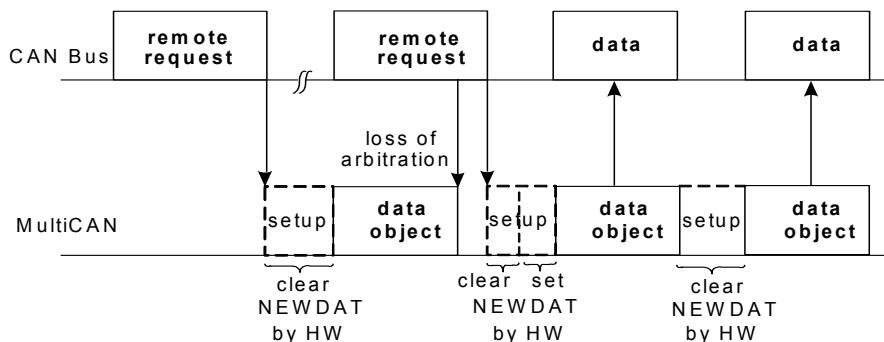
Figure 14 Loss of Arbitration

When the appropriate message object (data frame) triggered by the first remote frame wins the arbitration, it will be sent out and NEWDAT is not reset. This leads to an additional data frame, that will be sent by this message object (clearing NEWDAT).

There will, however, not be more data frames than there are corresponding remote requests.

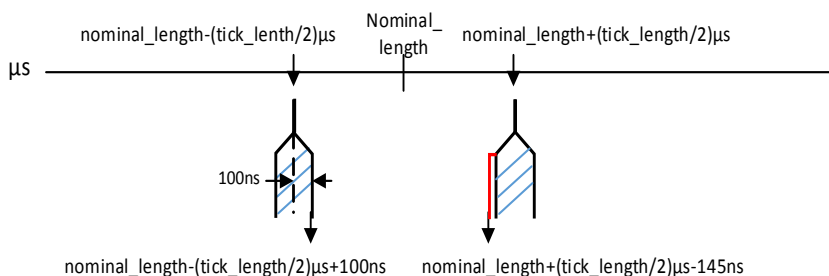
Figure 16 SENT Tolerance of this Design Step

In this design step the range is delimited as follows:

- The lower border is $\text{nominal_value} - (\text{tick_length}/2) \mu\text{s} + 100 \text{ ns}$
- The upper border is $\text{nominal_value} + (\text{tick_length}/2) \mu\text{s} - 145 \text{ ns}$.
