Errata Sheet V1.5 affecting products TC26x_BB

N° 164/17

Device TC26x
Marking/Step (E)ES-BB, BB
Package see Data Sheet

This Errata Sheet describes the deviations from the current user documentation.

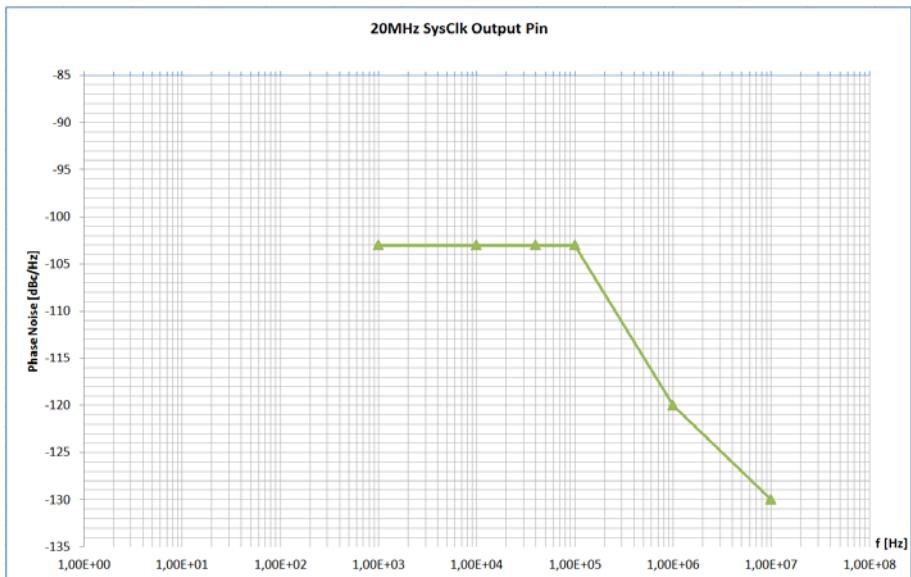
Figure 11 Phase Noise Density on SysClk Output Pin

Consistently, measurements on the HSSL/HSCT communication channel using the SysClk signal with I_{PN} from above show that the ultimate target of $BER_{20} = 10^{-12}$ is met. In such a measurement setup, both the master and the slave are microcontrollers of the AURIX™ family.

The diagram below shows the phase noise density on the SysClk pin when no application pattern but only the HSSL/HSCT subsystem is running:

Recommendation

When designing the PLL for an HSSL/HSCT ASIC, the values for I_{PN} and J_{ABS20} above and ultimately $BER_{20} = 10^{-12}$ can be achieved with the following recommendations:

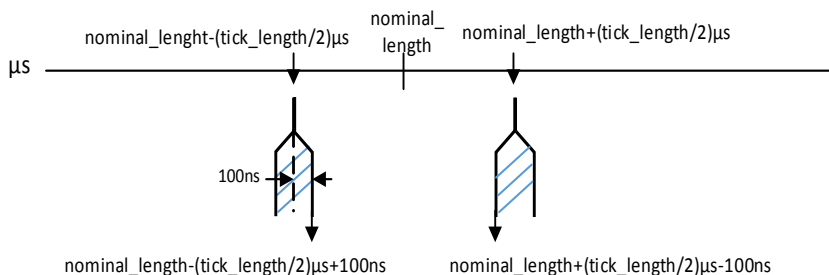
Figure 15 SENT Standard Tolerance

The length of a nibble in the SENT protocol determines the value of this nibble. For each value this length can vary, but it has to be at least inside a given range. This range is given by the SENT standard.

- The lower border is nominal_value-(tick_length/2) μs +100 ns
- The upper border is nominal_value+(tick_length/2) μs -**100** ns.

In this design step the range is delimited as follows:
